ENGINEERING INVESTIGATION REPORT  
ON  
LOSS OF THE SEACON'S CENTER WELL DOORS

FPO-1-80(2)  
DECEMBER 1979

OCEAN ENGINEERING  
AND CONSTRUCTION PROJECT OFFICE  
CHESAPEAKE DIVISION  
NAVAL FACILITIES ENGINEERING COMMAND  
WASHINGTON, D.C. 20374

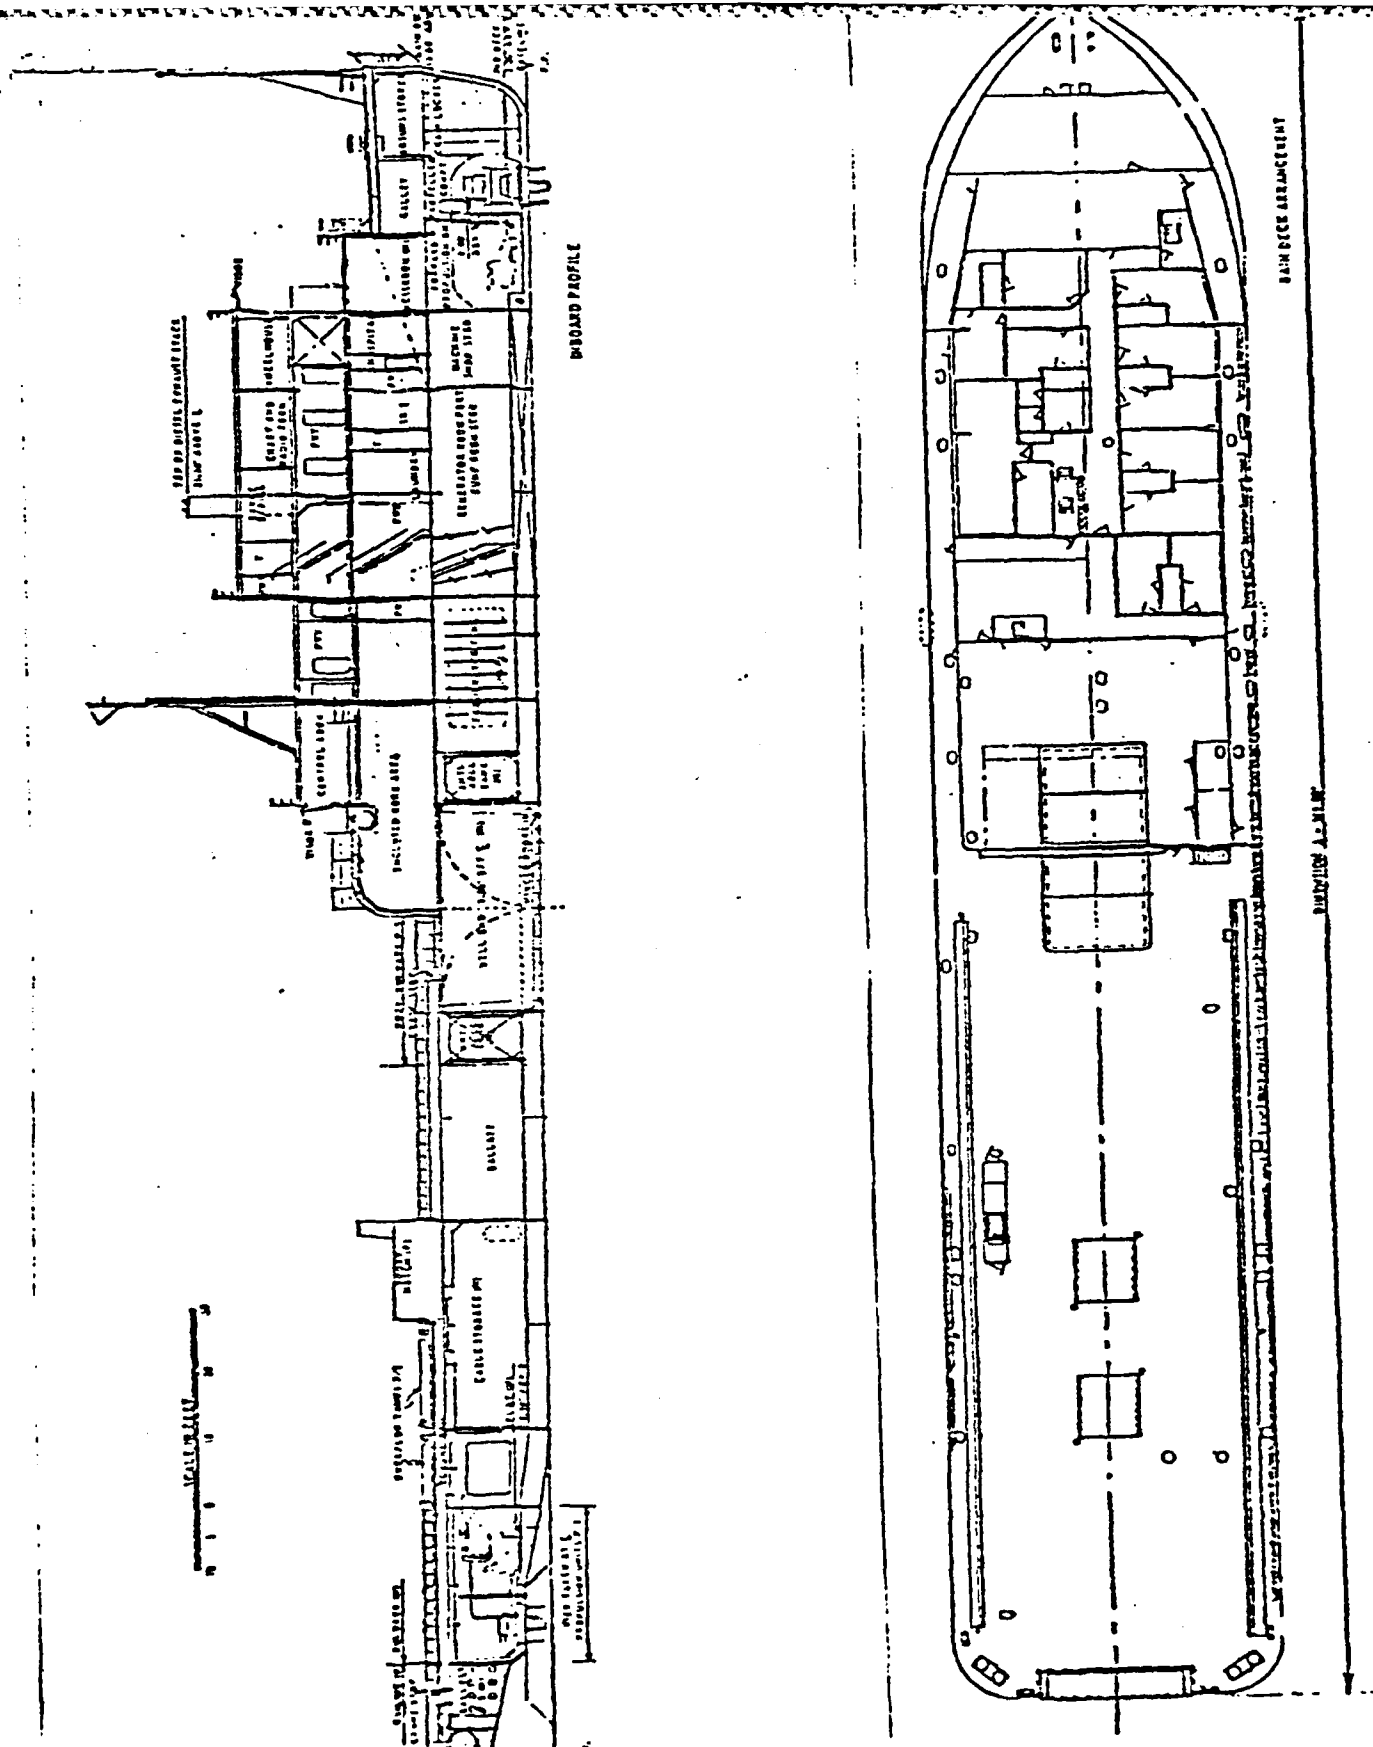
Figure 1. SEACON, GENERAL ARRANGEMENTS

3.1 Initial Service (1976 to May 1979): The SEACON was converted from a NASA YFNB to an ocean engineering and construction work platform by NAVFAC in 1976. Figure 1 shows the general arrangements of the vessel, the center well, the underwater doors and the hatch covers. Since its' launching, the SEACON has been utilized on a variety of Navy ocean engineering and construction projects. Many of these missions have used the launch and recovery capability of the center well feature; and no difficulties were experienced with it either self-powered, or under tow prior to this.

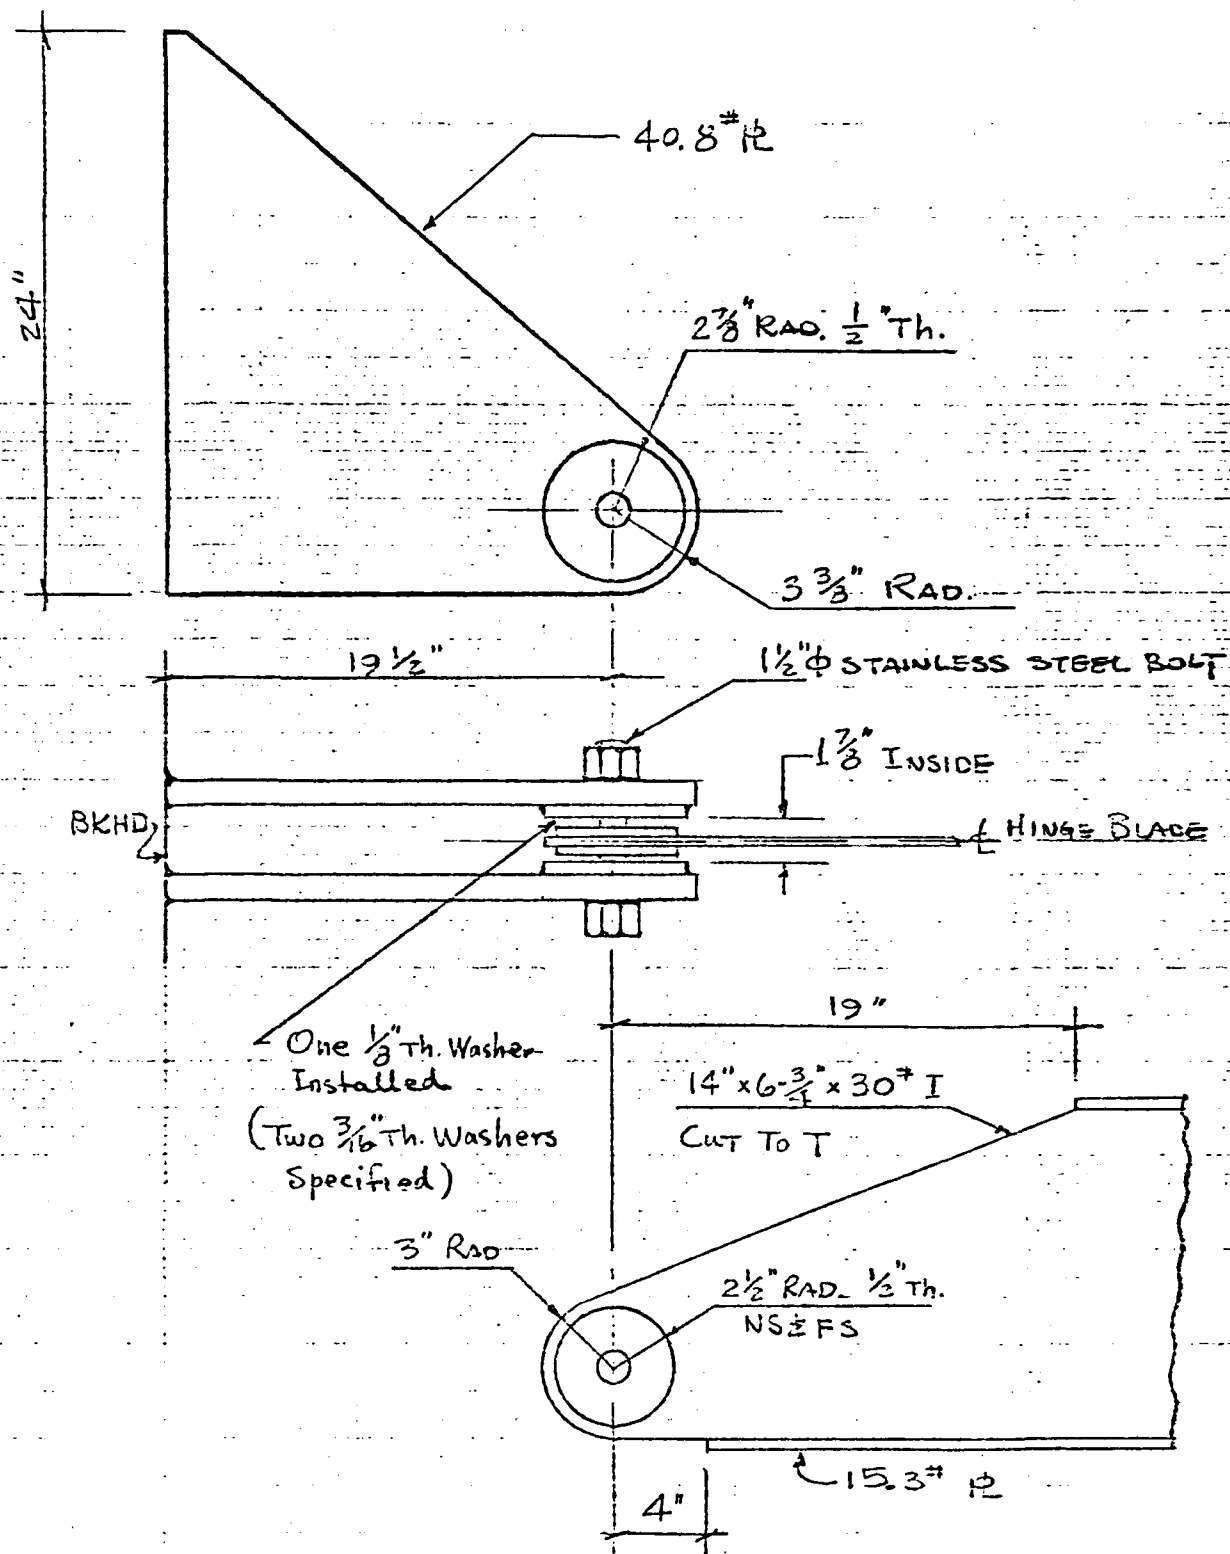
SK-01 CENTER WELL DOOR HINGES

4.1 Door Design: The door design was found to be structurally sound except for members which formed part of the door-hinges. Two 14" deep beams run longitudinally as stiffeners. These are spaced 1/3 of the door-width apart; and a portion of the web of each beam extends to form a door-hinge-blade as shown by the sketch SK-01. The beams are adequate as stiffeners; but the 1/4" web does not provide adequate material for this particular design application of a hinge.

4.2 Hinge Design: SK-01 shows some of the critical details of the hinge assembly design. The two hinge-blades welded to the bulkheads and lower sill of the well are large pieces of 1" plate which are well supported by the ship structure. On the other hand, there is only one door hinge-blade per assembly; and it is only 1/4" thick. The design provides a poor balance in both strength and stiffness between the bulkhead hinge and the door hinge blades. It provides an equal disparity between vertical load capacity of the hinge assembly and the side-load capacity of the door hinge-blade. This latter deficiency fails to accommodate side-loads on the door caused by ship roll, yaw and sway; yet no other provision was made for taking such loads at the hinge-ends of the two doors. The inability of the hold down mechanisms, at the opposite end of the doors, to help alleviate this is discussed below. These hinge elements accumulated several million cycles of side load in the period between 1976 and the present. The condition exists whether the doors are in the up position, or in the down position. Even though this did not result in any noticeable permanent-set bending of the blades, they were certainly exposed to cyclic loads that under a combination of conditions could (and did) cause the failure of the door hinges. This design deficiency could only be aggravated by the omission of the spacer washers by the shipyard. Thus an increment of cyclic shock loading was added to the cyclic flexural loading on the hinge assembly (and the door hinge-blade in particular). The designer either overlooked this side loading condition, or he assumed that the hold down mechanisms at the opposite end of the doors would prevent side motion of the doors and side-loading of the hinge blades. In any case, the brilliance of hindsight shows that he was wrong in selecting this hinge configuration.

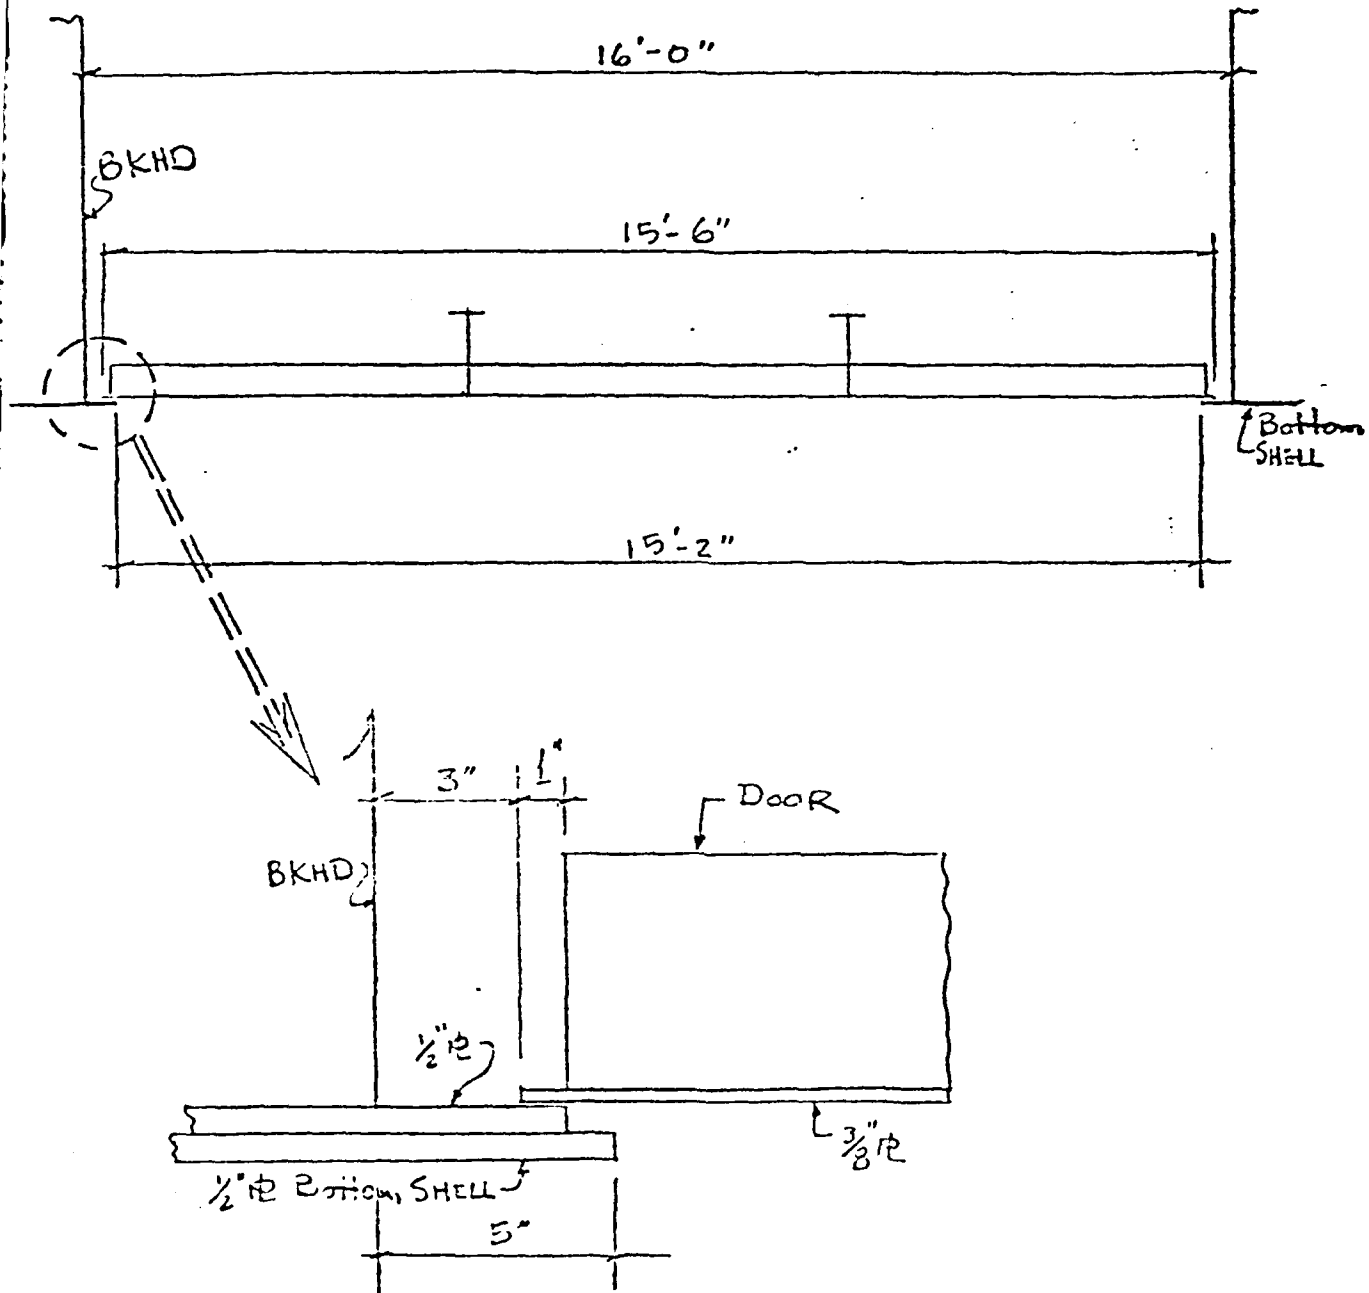
SK-02 DOOR SILL INTERFACE

4.3 Door Sill Design: SK-02 shows the interface of the doors and the door side-sills based on nominal dimensions. It can be seen that if the side motion of the doors is not restrained by the hinges at one end, and the hold down mechanisms at the other, the door can escape the door sill and fall out. Note: there is no overlap between the doors and the fore and aft "sills". Thus the failure of the door hinges at one end, and

inability of the hold downs to prevent side motion at the other end, can permit a door to drop out of the well (and it did). It should also be noticed that the bearing between the door and the sill is greatly weakened by the 1" setback between the doublers and the shell plating on the two parts. Also note that this discussion is without any consideration as to the unknown tolerances and fit-up of the ship and the doors.

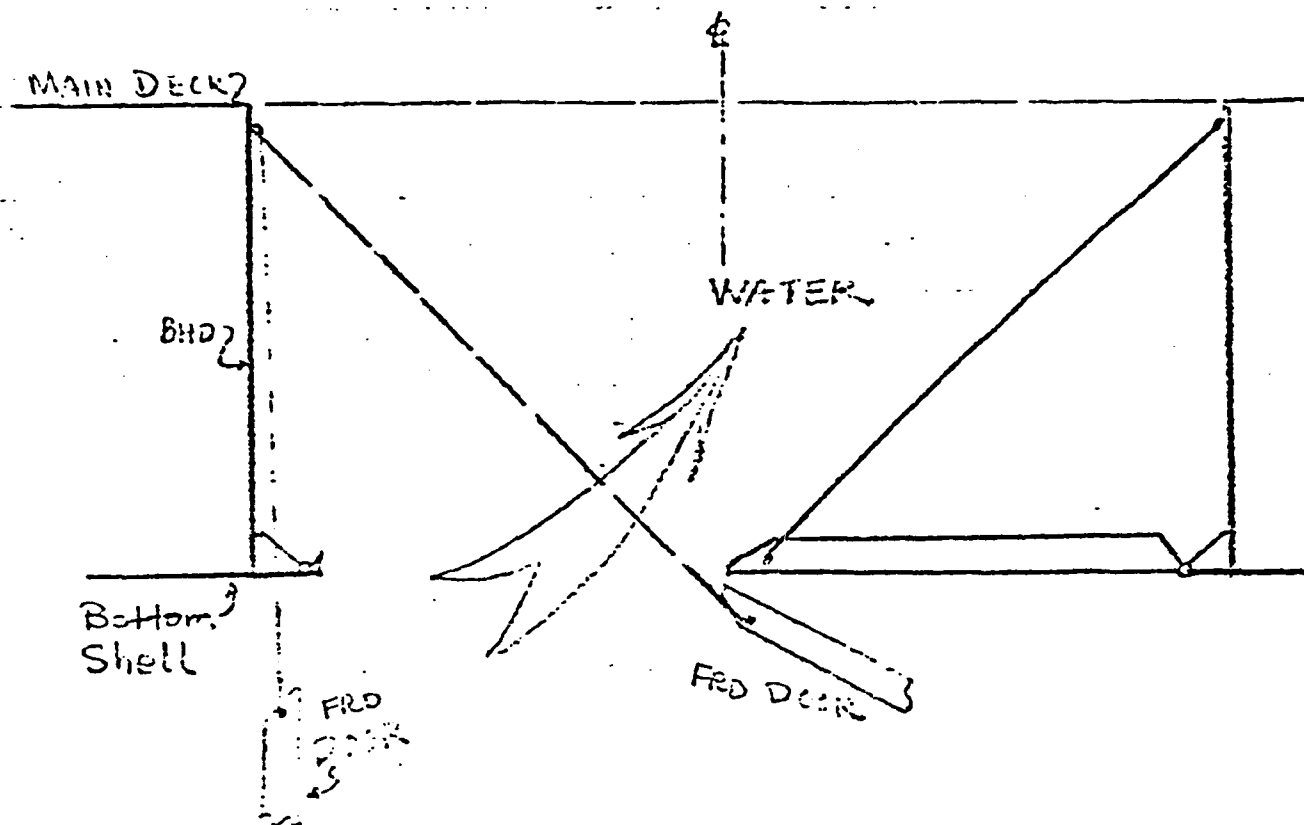
SK-03 FOREWARD DOOR FALL-OUT

5.1 Loss of Forward Door: The door hinge-blades of both doors had suffered progressive deterioration due to cyclic side loads during past operations; so that while under tow in fairly high following seas the foreward door hinge blades broke off. The hold downs did not have sufficient clamping power to restrain the side loads on the hinges; and when the hinges broke, the clamping action was not sufficient to restrain the door from sliding sidewise, escaping the sills and falling out of the well. The falling door was restrained by its' two lift cables and brought up against the leading edge of the aft door as shown in SK-03. Here the two lift cables were abraded and broken away and the door was released and lost.
